New Approaches for Performance Definition
of Composite Materials and Structures
NPL, London 11th March 2010

**‘ NDE OF COMPOSITE
MARINE STRUCTURES ’**

Dr Holly Phillips
Principal Naval Architect
RNLI

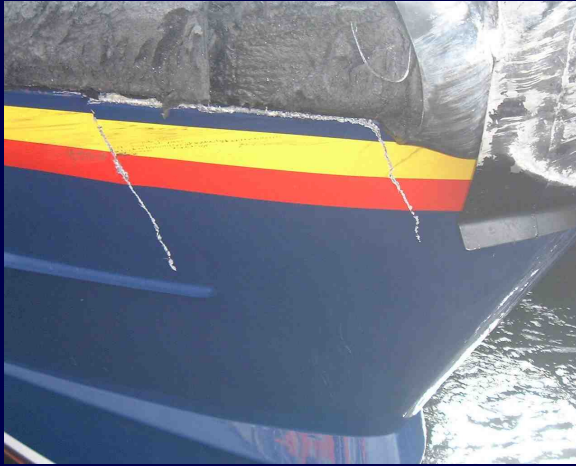
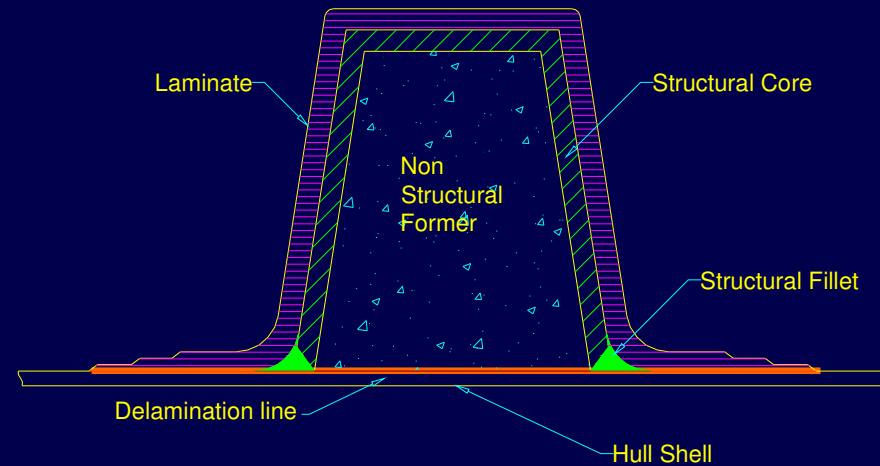
- Delamination of monolithic outer hull from internal stiffeners.
- Plotting of subsurface damage in area of visible surface cracking.

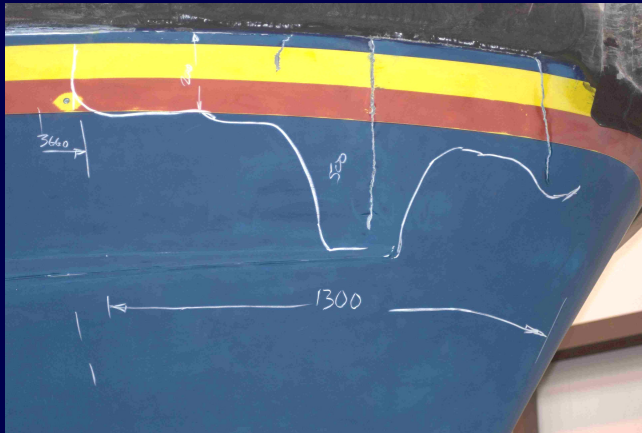
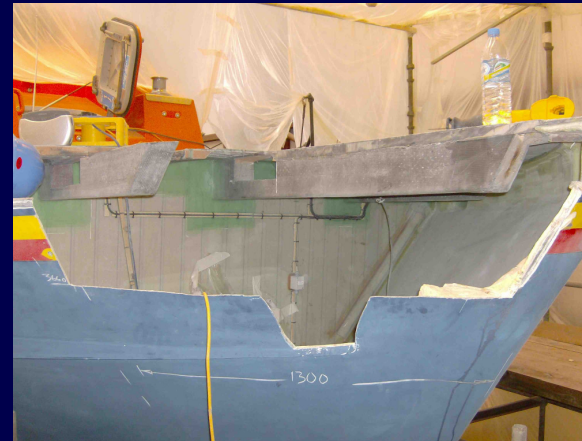
CASE STUDY 1: Bow Damage Assessment

- Aim is to assess extent of damage in order to determine cut lines prior to cutting away damaged structure

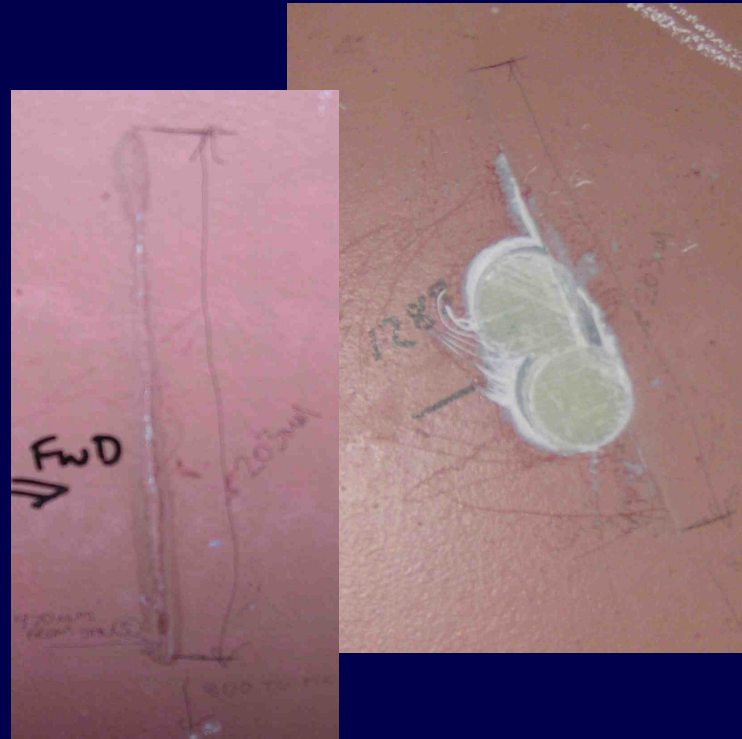
CASE STUDY 2: Impact damage to outer hull

- An impact had produced a crack in the monolithic outer hull.
- An area of delamination could be seen and the surface was removed by drilling.
- Before effecting repairs the extent of the delamination needed to be determined.
- It was suspected that the drilling could have induced more damage.

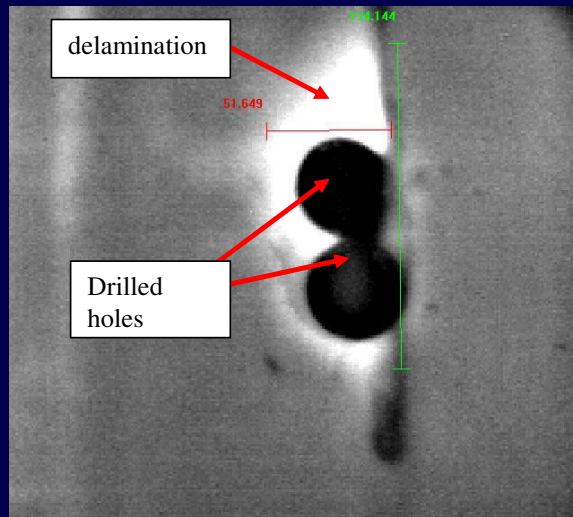
Pulsed thermography
used to define damage
area for scarf repair

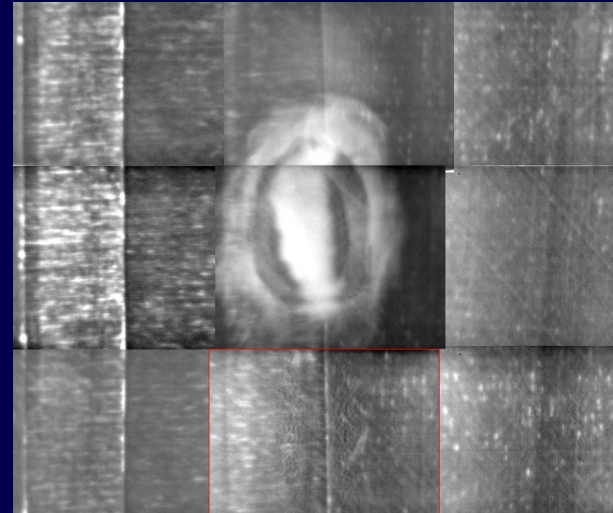
Composite image of
repaired area used for
monitoring integrity
during service

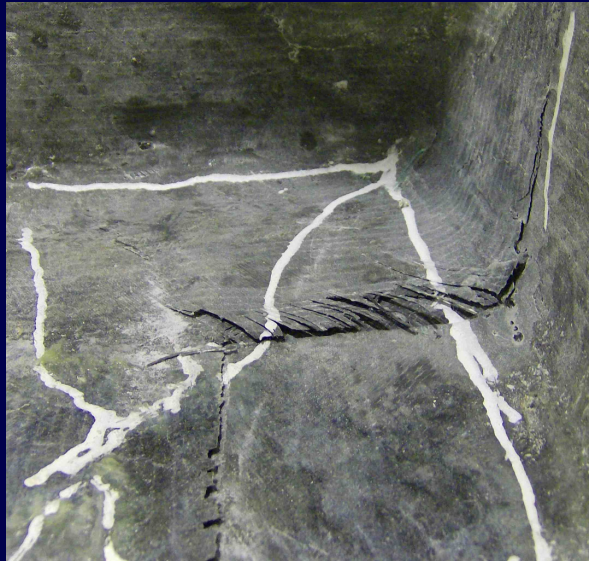
CASE STUDY 3: Debonding of Stiffeners from Hull

An impact had resulted in debonding of some of the stiffeners from the outer hull

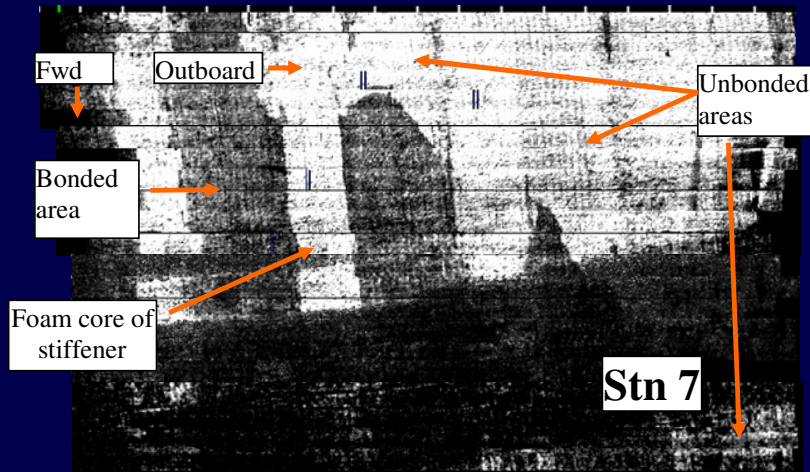
- The damage area was mapped and the disbonded areas show as white
- The area was rescanned after repair

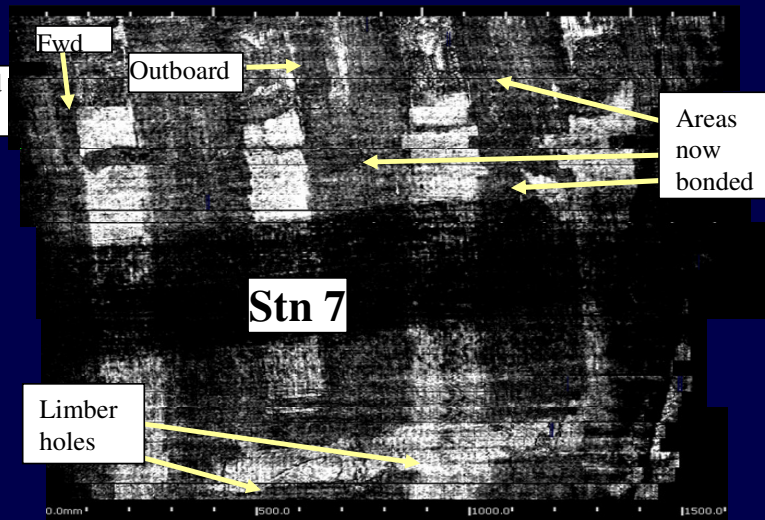
- The newly bonded areas are clearly seen
- Images can be used to monitor structure in service and inform life extension decisions
