New Approaches for Performance Definition
of Composite Materials and Structures
NPL, London 11th March 2010

**‘ NDE OF COMPOSITE
MARINE STRUCTURES ’**

Dr Holly Phillips
Principal Naval Architect
RNLI

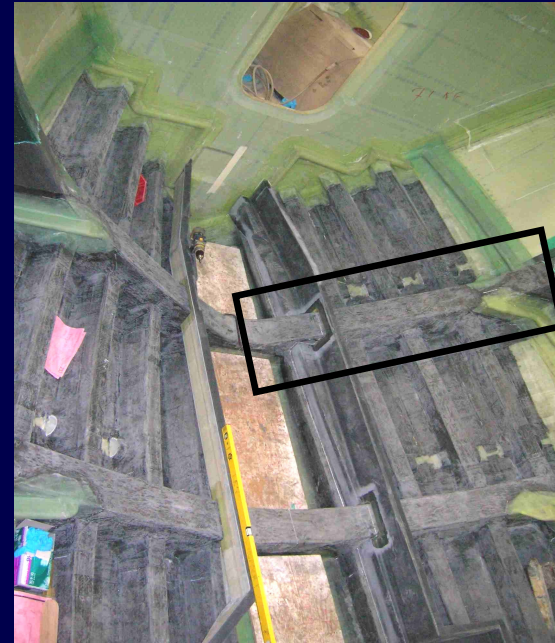
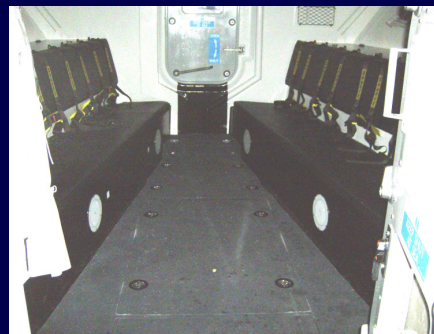
CASE STUDY 3: Debonding of Stiffeners from Hull

An impact had resulted in debonding of some of the stiffeners from the outer hull
