Structural Response of CFRP Materials Subjected to Simulated Lightning Strikes

Abstract

The buckling response of Carbon Fibre Reinforced Polymer (CFRP) panels damaged by simulated lightning strikes is evaluated. Five panels constructed with carbon/epoxy material were subjected to an electrical current with 10/350 μ s waveform that simulates an idealized lightning strike. The buckling experiments were conducted in a newly designed modified buckling test, herein referred to as Compression After Lightning Strike (CALS), which is able to accommodate large composite panels and allows the full extent of the lightning damage to be included in the compression test. Stereo Digital Image Correlation (DIC) was used on both sides of the plate to obtain the strain and displacements that occur during the CALS test and hence determine how the lightning strike affects the mechanical performance of the structure. The experimental results were benchmarked and compared against a shell post-buckling finite element model (FEM). The results reported show good agreement between the experiment and the model predictions.

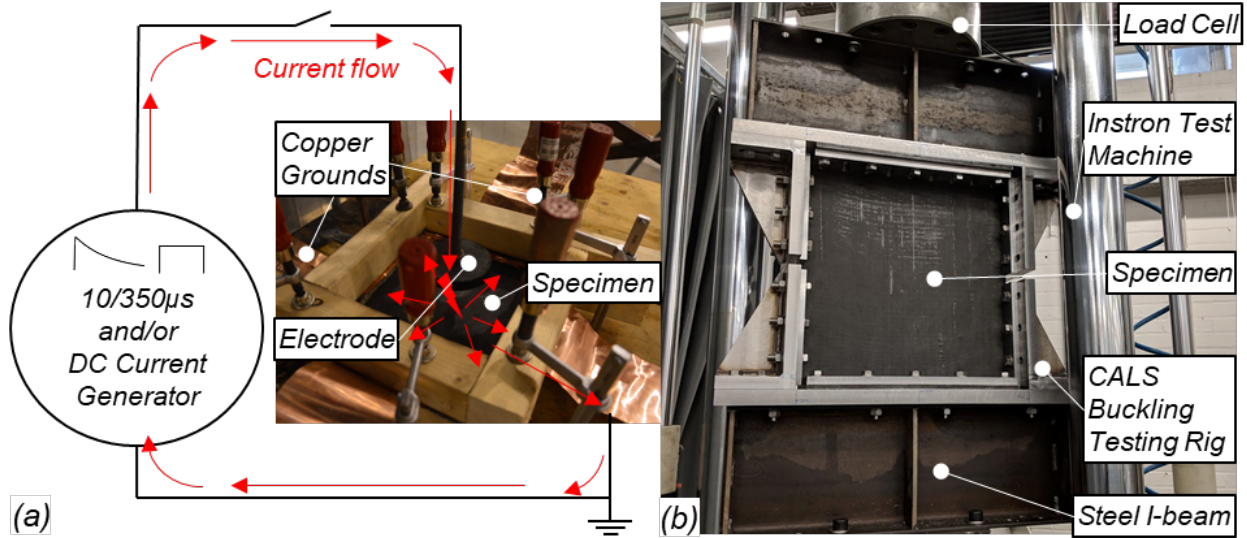
Fig. 2: Experimental setup for complete test: (a) lightning strike damage setup and circuit diagram; (b) structural test showing CALS rig

samples were 50, 75, 100, and 125kA. Two of the damage samples are shown in Fig. 1(b)(c). The lightning strike simulation setup is shown in Fig. 2(a). After the lightning strike, the damaged and the control specimens were cut using a waterjet cutter to a final plate dimension of 500mm square as shown in Fig. 1.

A new rig was designed and manufactured to capture the effects of lightning strike induced damage on the structural scale. The new CALS test configuration and rig is shown in Fig. 2(b). The upscaling was done to fit a variety of plate widths and lengths (larger than 450mm), to closely resemble WT blade sparcap structures close to the blade tip where the propensity for direct lightning strike is the most severe. The rig was designed with interchangeable supports, and configured to a simply supported plate system for the present study. The CFRP plates were loaded in the fibre direction with a 0.5mm/min loading rate in compression. The tests were conducted, so that the buckling and post-buckling responses could be studied using DIC on both sides of the plate. The test setup parameters are shown in Table 1.
