# Structural Response of CFRP Materials Subjected to Simulated Lightning Strikes

TIMOTHY M HARRELL<sup>1</sup>, OLE T THOMSEN<sup>2</sup>, JANICE M DULIEU-BARTON<sup>2</sup>

14<sup>TH</sup> INTERNATIONAL CONFERENCE ON ADVANCES IN EXPERIMENTAL MECHANICS

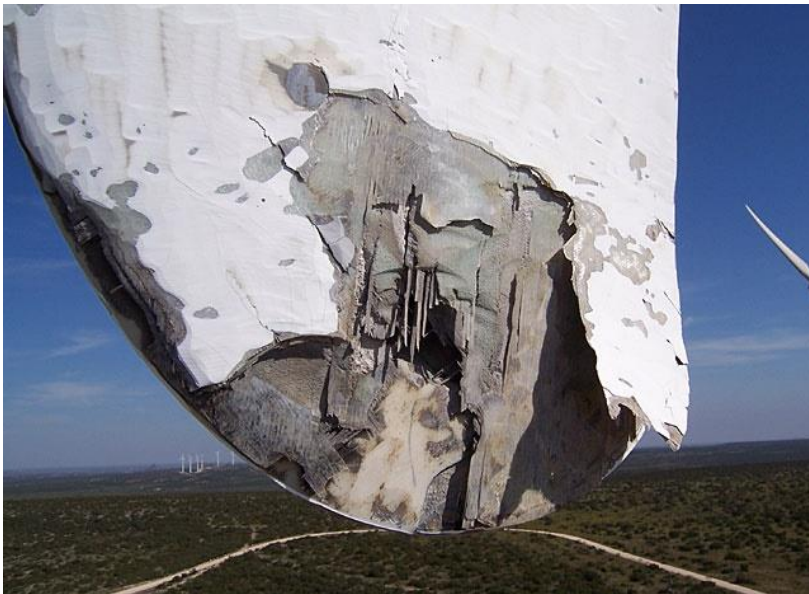
Burning/charring

- Lightning can strike wind turbines up to 30 times per year
- 5 times greater energy than aircraft standard (10 MJ/ $\Omega$ )
- **Costing operator millions of pounds a year**

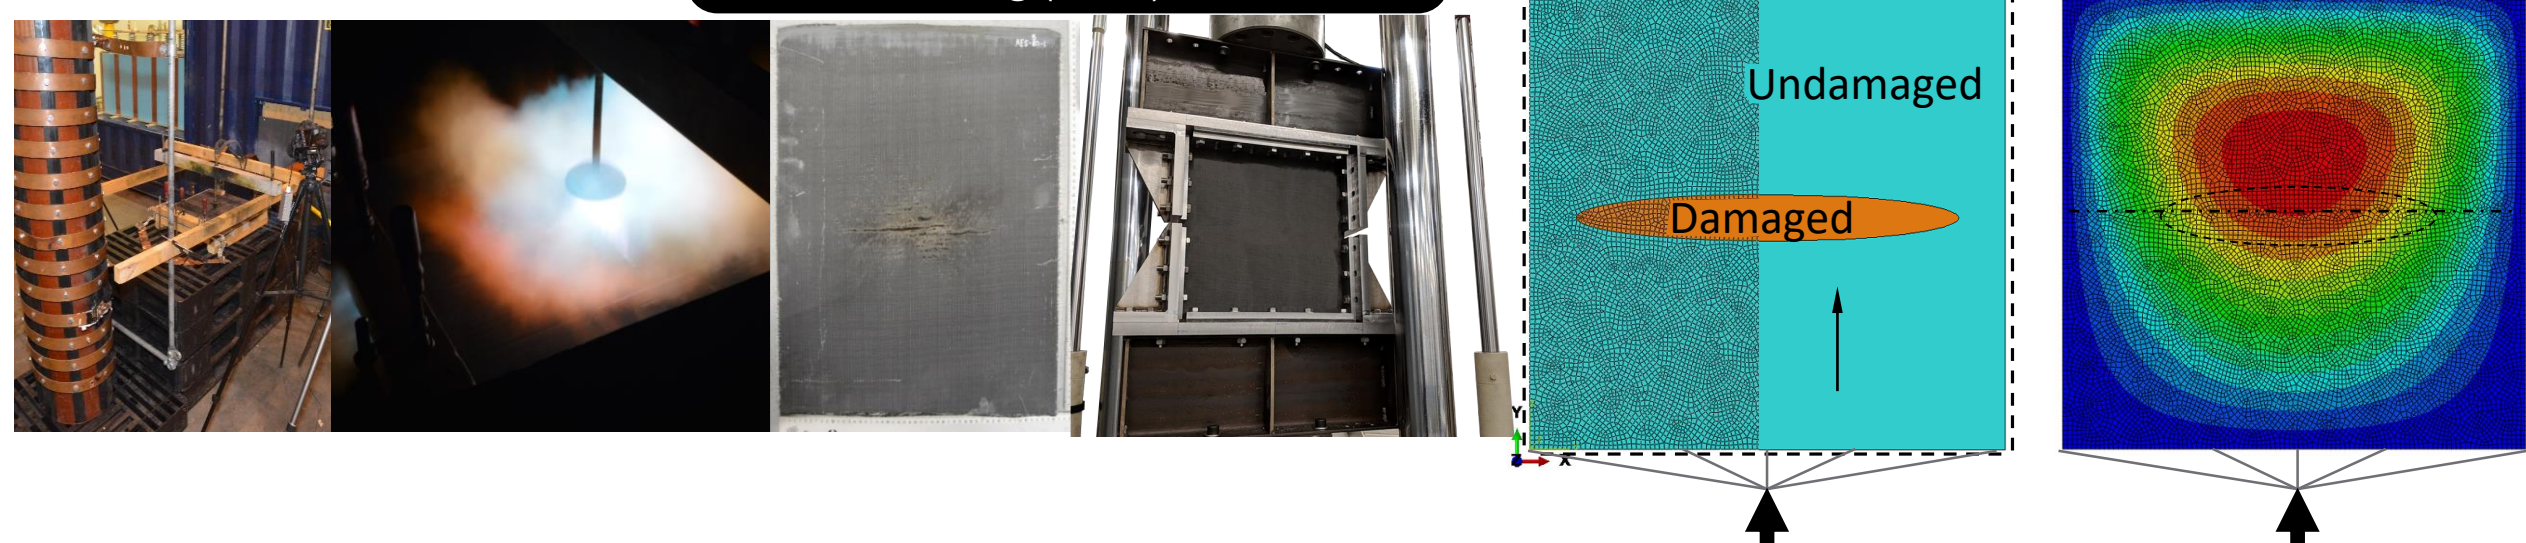
- Predict structural response of CFRP after a lightning strike:
  - Developing experimental procedure
  - Development of modelling framework
  - Compare/Validate

Simulated Lightning Strike Experiment

Sub-Structural Buckling Test in Compression After Lightning Strike Rig (CALS)

Structural Model

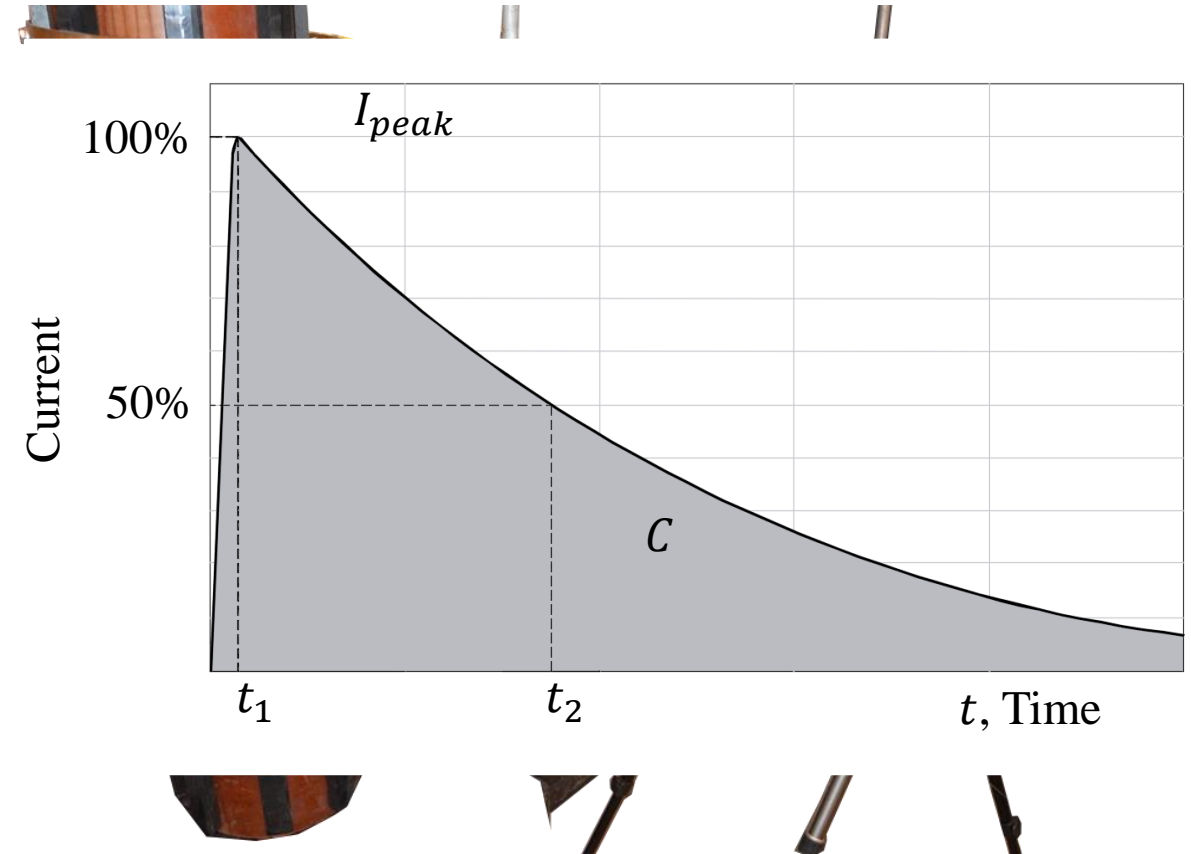
- 14 x CFRP unidirectional (UD) eight ply laminate
  - 800 gsm fabric
  - Epoxy Resin Matrix
- 550 mm long x 500 mm wide x 7 mm thick
- 10/350 $\mu$ s waveform
- Peak Current shown:
  - 50kA
  - 125kA

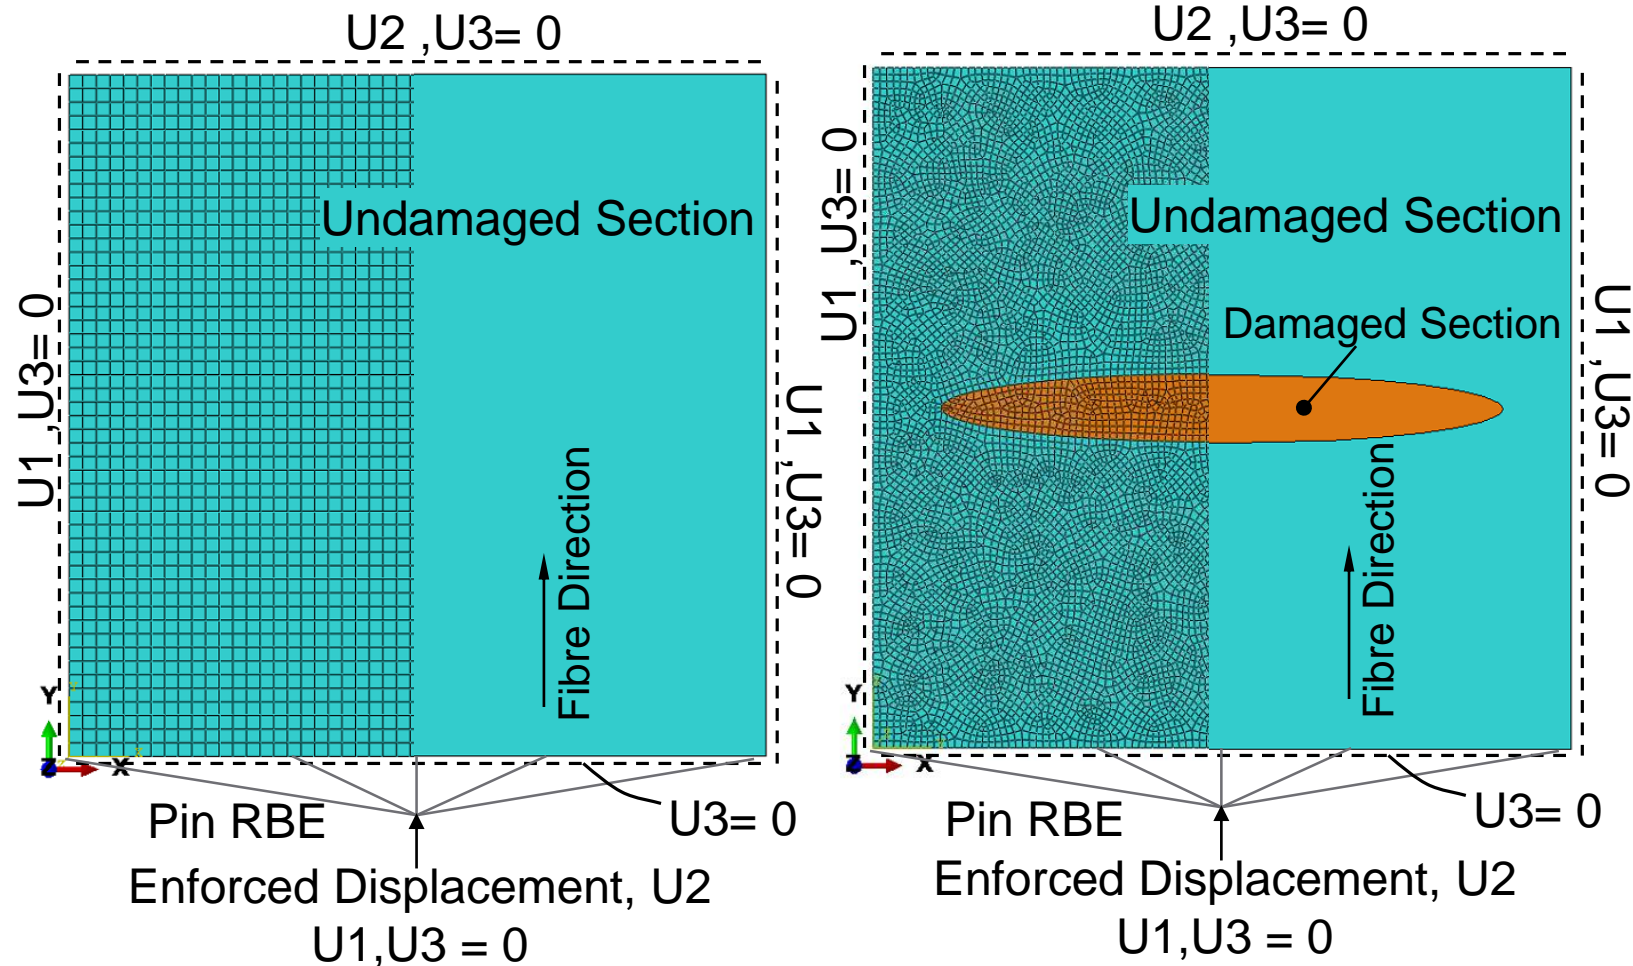
- Shell post-buckling finite element model with large deformations
- Abaqus 6.14 Riks Method with S4R shell elements
- The area of the damage was assessed using the visual inspection and CT
- Damaged areas taken into account by reducing stiffness to essentially zero

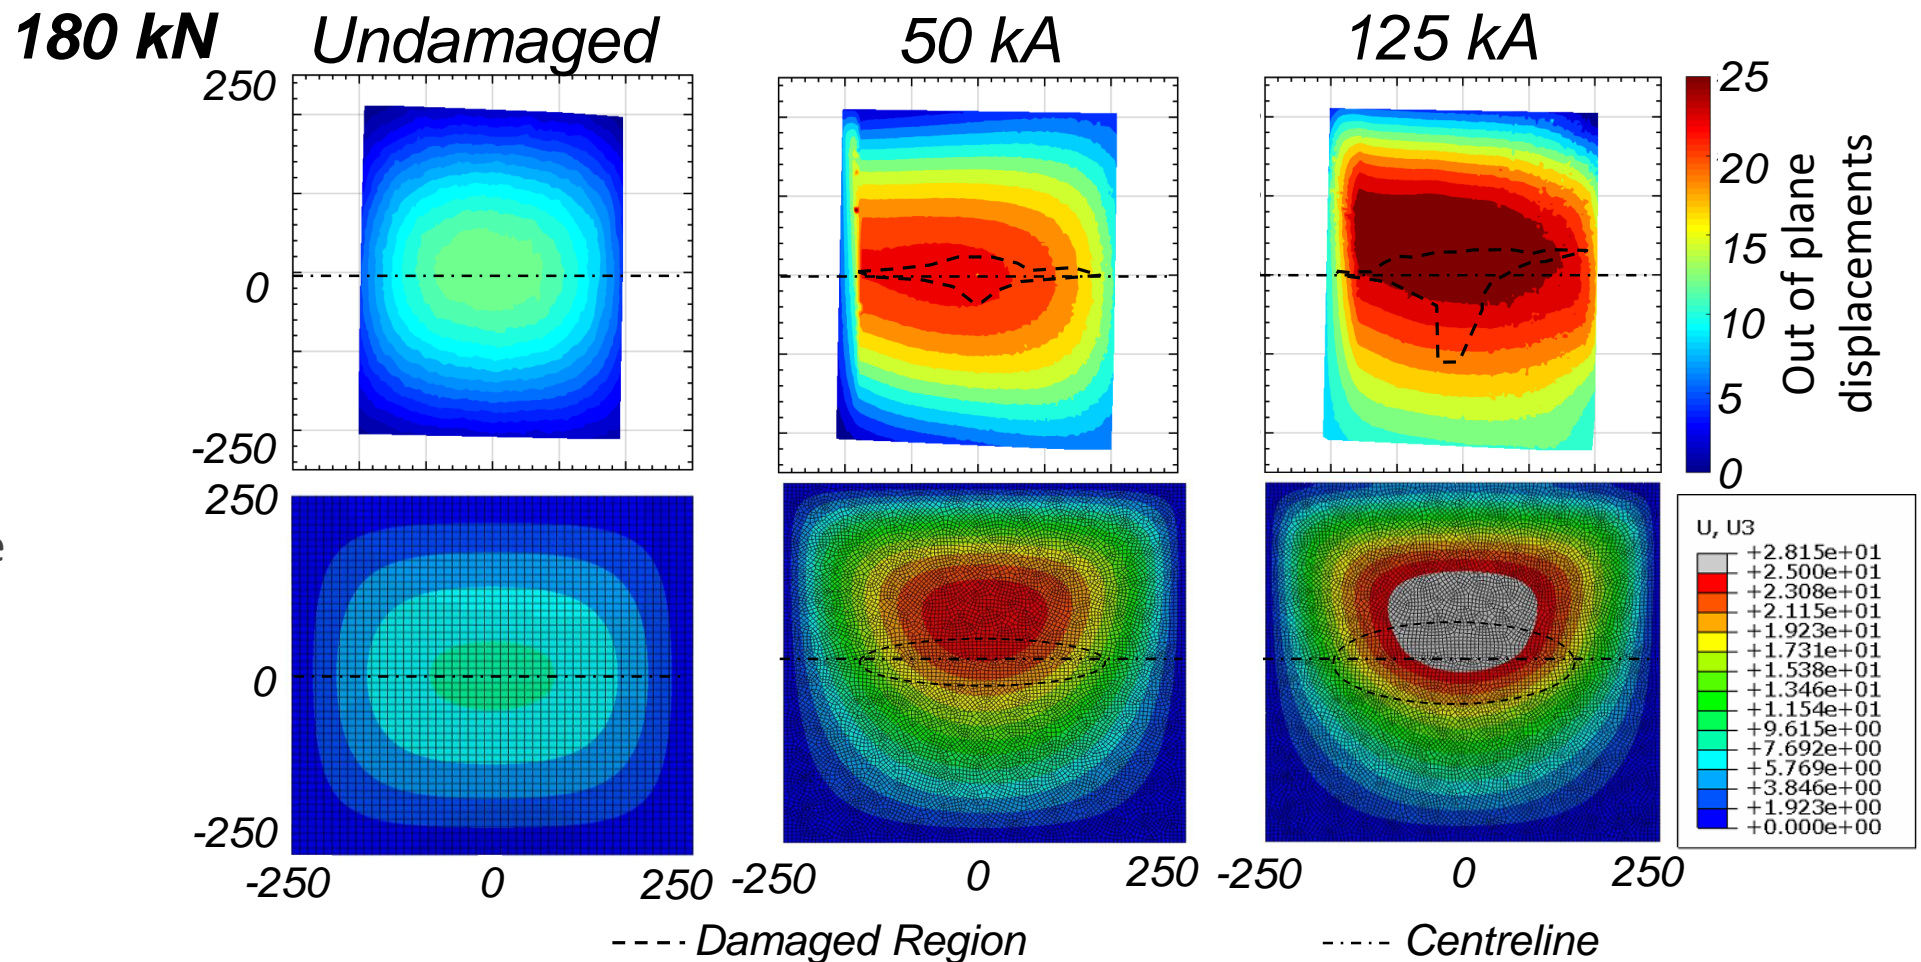
- The most severely damaged specimen (lightning strike of 125kA) for all load levels showed:
  - highest displacement levels
  - a change in the displacement field moving away from the damaged region.
