In Situ Study of Deformation and Fracture in a 3D Printed Short Fibre Composite

Abstract. 3D printed structural composites can be manufactured with controlled anisotropic microstructures but contain intrinsic voids and may have inhomogeneous spatial distributions of fibres. These defects may reduce the mechanical performance, which would limit their application as structural materials. In situ X-ray tomography and digital volume correlation have been used to volumetrically characterise a polylactic acid (PLA)-basalt short fibre 3D printed composite during tensile testing to failure. The analysis distinguished the crack initiation region using the discontinuity of the displacement field, before the crack was visible. The ability to directly correlate the microstructure with crack formation may support improved control of the void distribution to design 3D printed materials with enhanced mechanical performance.

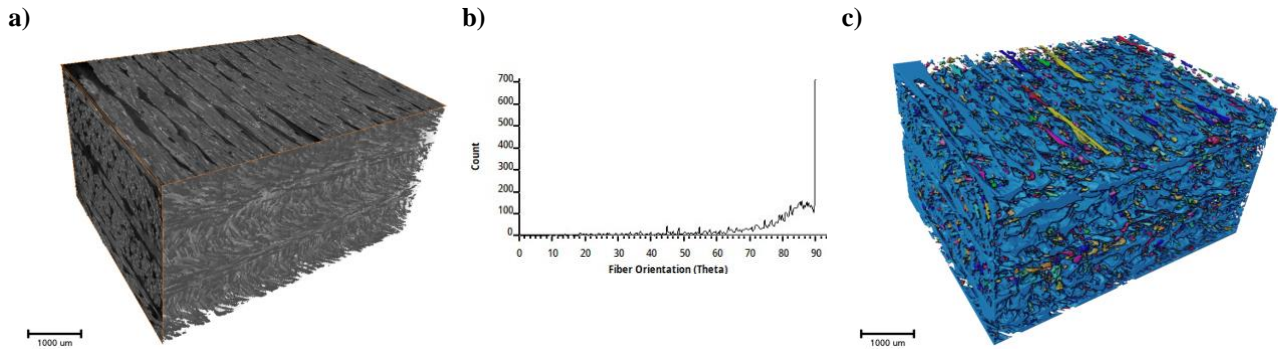
Figure 1. a) X-ray tomograph of the composite; b) histogram of fiber orientation in a 90-degree layer with 0.35° bin size; c) void distribution in 3D space. The blue voids were connected, the others were isolated.

Fig.1 (a) shows a visualisation of the initial X-ray tomograph of the Basalt-PLA composite. The tomograph was segmented, based on image intensity, to quantify the fibre orientations and void distributions in 3D space. Fig. 1 (b) shows a histogram of the fibre orientation within one of the 90° layers. The fibres were well oriented, parallel to the filament direction, though some fibres were distributed less effectively. The total volume fraction of the void was 18.8% before loading, increasing to 20.5% after a nominal strain of 3% that led to stable crack formation. Most of the void fraction was connected (in blue) and located mainly between the layers due to the imperfect fusion of the filaments. Small voids are also found within the filaments.

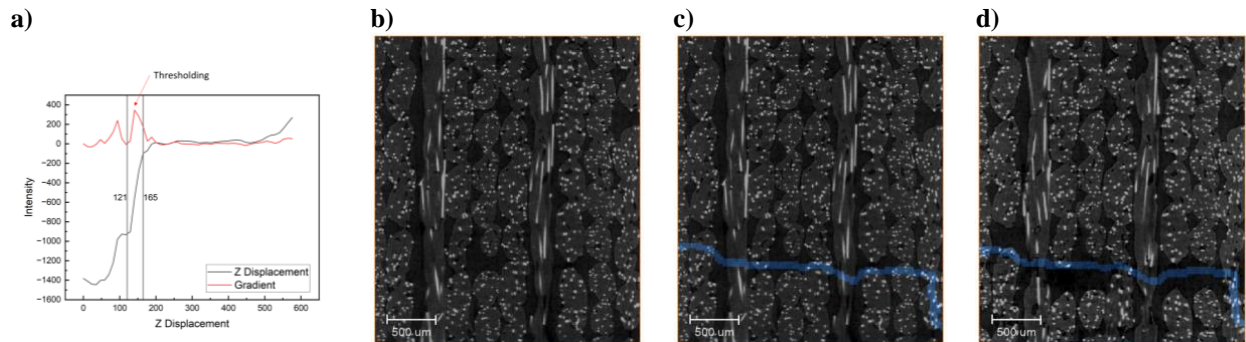
Figure 2: Damage visualization: a) the variation of displacement along Z-axis (loading direction) and the displacement gradient, after loading to a nominal strain of 3% from the initial state; b) ortho slice of the tomograph in the Y-Z plane at 3% nominal strain; c) the displacement discontinuity superposed over the same image as b) and d) then after significant damage at a nominal strain of 5%.

The crack that caused the ultimate tensile failure was detected using the displacement gradient that was measured by DVC. An example line profile of the displacement U_z at the initial stage in the loading direction (Z axis) is shown in Fig.2 (b). The crack was not yet visible - see Fig.2 (b and c), but threshold analysis of the displacement gradient can map the discontinuity onto the tomographs, as in Fig.2 (c and d). This coincides with disconnection between filaments and filament necking that developed into the visible crack after a nominal strain of 5%, as Fig.2 (d) shows. The crack propagated through interlayer-voids and caused delamination, with no significant interaction with the fibres. This shows that the interfilament voids are the dominant factor in determining the mechanical properties. Void reduction, such as via a post-printing heat treatment, might enhance the resistance to fracture.
